**Christians and Creation**  
**Energy Efficiency Upgrades at St. Luke's (Part 1)**  
**- 30% Savings within Two Years -**

by Mike Cruickshank  
April 2007

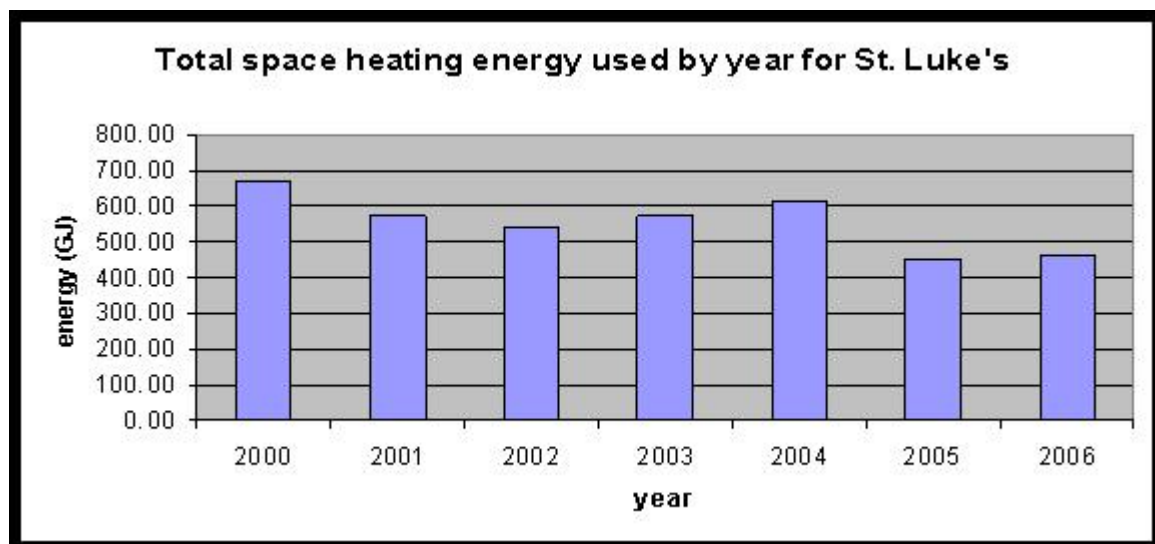
**After the extra repairs were completed our overall savings increased significantly. Upgrades done in 2005 and 2006 yielded average savings of about 25% compared to the previous 5 years (see graph). If the annual temperature differences between years are taken into account, the savings are greater than 30%. About 20 tons of carbon emissions and about \$2300 were saved annually. Thus, a payback of less than one year was achieved with volunteer labour.**
